GEORADAR RESEARCH OF PARTERRE IN HISTORIC PARK IN PALARIKOVO

This work is a part of a wider research project of historic greenery in south-western region of Slovakia. As a model object was chosen garden parterre of a 19th century landscape park in the village of Palarikovo in Nove Zamky district. As a working method was chosen non-invasive underground research with the use of georadar X3M equipped with 500 MHz shielded antenna of Swedish company MALÅ. Research results were processed by software Rad Explorer 1.41 and GroundVision 2. Planar scanning of the eastern half of parterre in range 30 × 50 m was chosen with the goal to verify presumption on an existence of a formal parterre design preserved in graphic plans dated 1794. Decision was made due to expectation of symmetry in composition of classicistic parterre. A set of 100 scans in a perpendicular direction to the main parterre axis (each 25 to 30 m long repeated each 50 cm). As controls were made 5 scans parallel with the main parterre axis (each 50 m long repeated each 5 m). The research itself was made during the summer months in 2012 as the best scanning results can be reached only in dry and warm conditions. According the

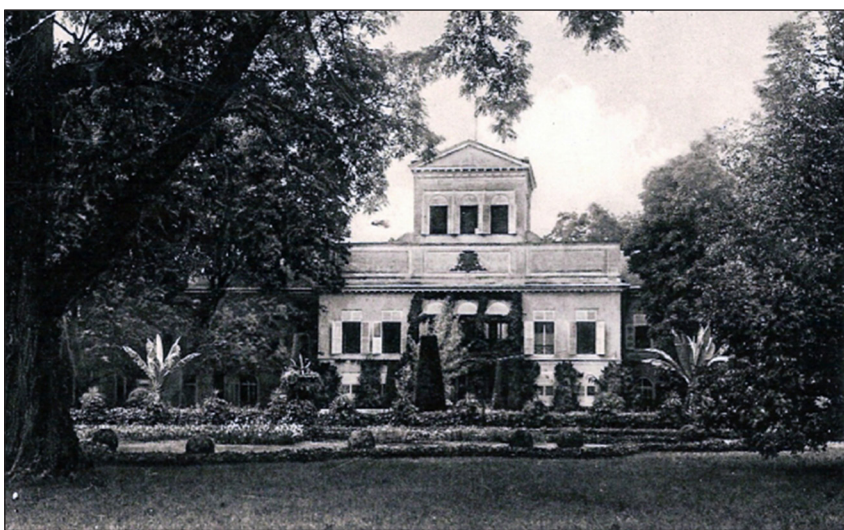
Figure 1 Design of the Court d'honneur in front of the Count Karolyi's Manor House in today's Palarikovo

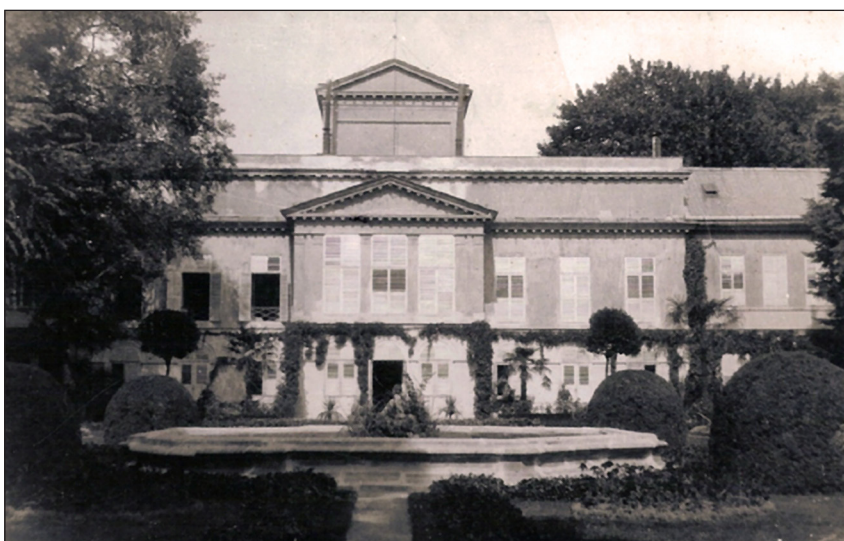
Figure 2 Design of the garden parterre behind the Count Karolyi's Manor House in today's Palarikovo

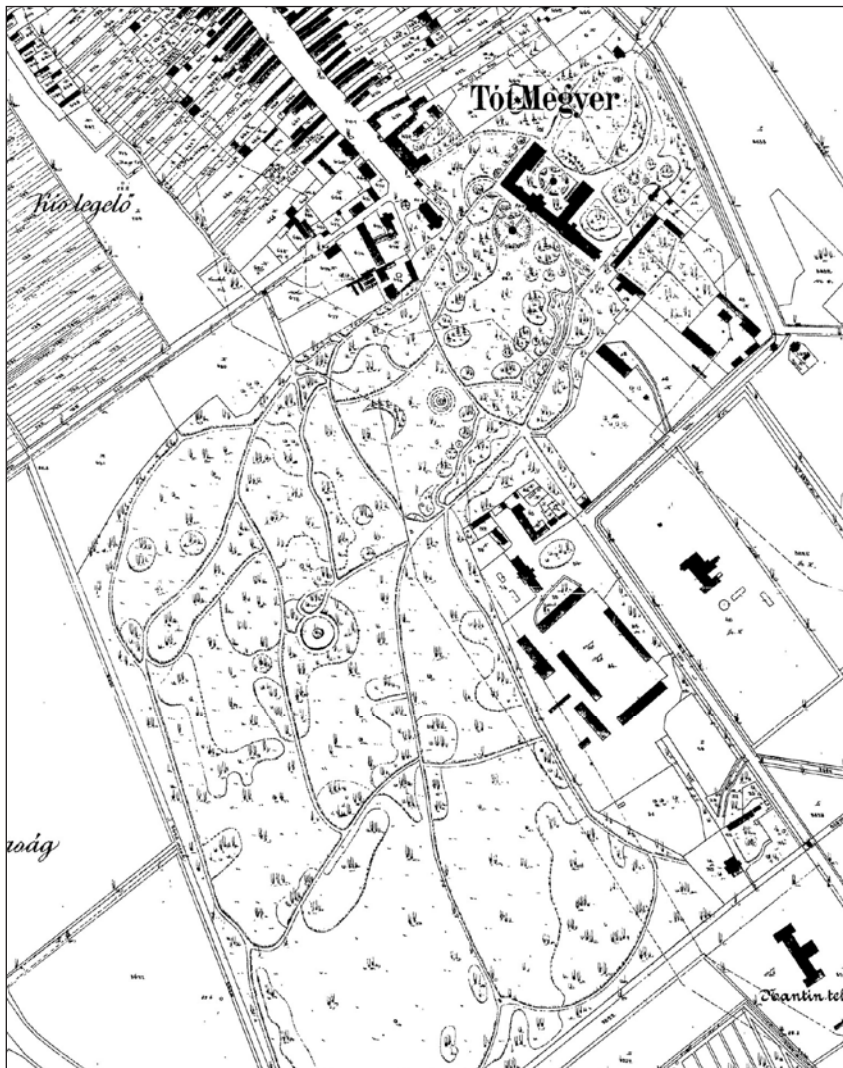
Figure 3 Historic cadastral map from the turn of the 19th and 20th century showing the formal design of both parterres. Red line marks surveyed area
Source: Archive of the Geodetic and Cartographic Institute Bratislava

to the digital maps and still existing manor. There is an expectation of small map inaccuracy as the original plans were made manually. That is why planar method was chosen in the area of the south-eastern half of the parterre in range 30 × 50 m. Decision was made due to expectation of symmetry in composition of classicistic parterre. A set of 100 scans in a perpendicular direction to the main parterre axis (each 25 to 30 m long repeated each 50 cm). As controls were made 5 scans parallel

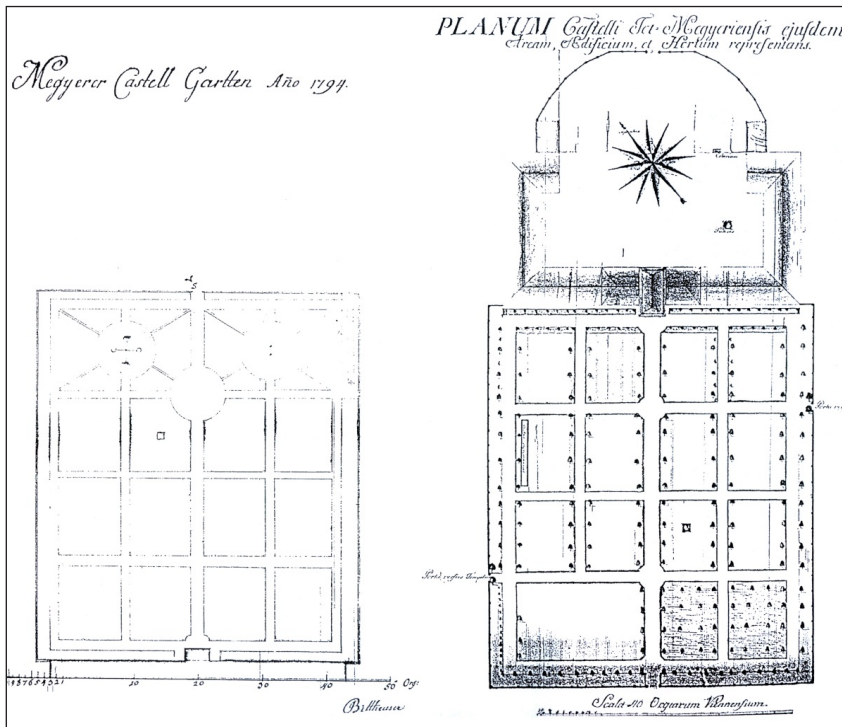
Figure 4 Historic garden parterre proposal plans dated 1794
Source: Archive of the Monuments Board of the Slovak Republic Bratislava

graphics of garden parterre plans in formal baroque style. Both were simple geometric compositions of several rectangles circumscribed by hedges probably of boxwood (*Buxus sempervirens* L.) with incorporated tennis court and peach orchard (*Persica vulgaris* Mill.). Today is the parterre non-formal with poor quality lawn but with still readable marks of formal design from the turn of the 19th and 20th century. It is the mentioned fountain and 4 not very visible roundish terrain elevations (approximately 15 cm high and 4 m in diameter) positioned around the fountain in corners of a square shape. These elevations are with high level

According to our research results it is possible to come to the conclusion that historic garden parterre proposals of a formal design (dated 1794) were never realised. There were readable only marks of the composition from the turn of the 19th and 20th century. Possible mistakes can be disproved by an invasive archaeological research; they could be caused in case of gradual sedimentation of mould paths to the state aligning the density of the soil and former path. Or in case of out planting stripes the soil could be compressed during the time since the change happened. According the research results we do not assume these cases.

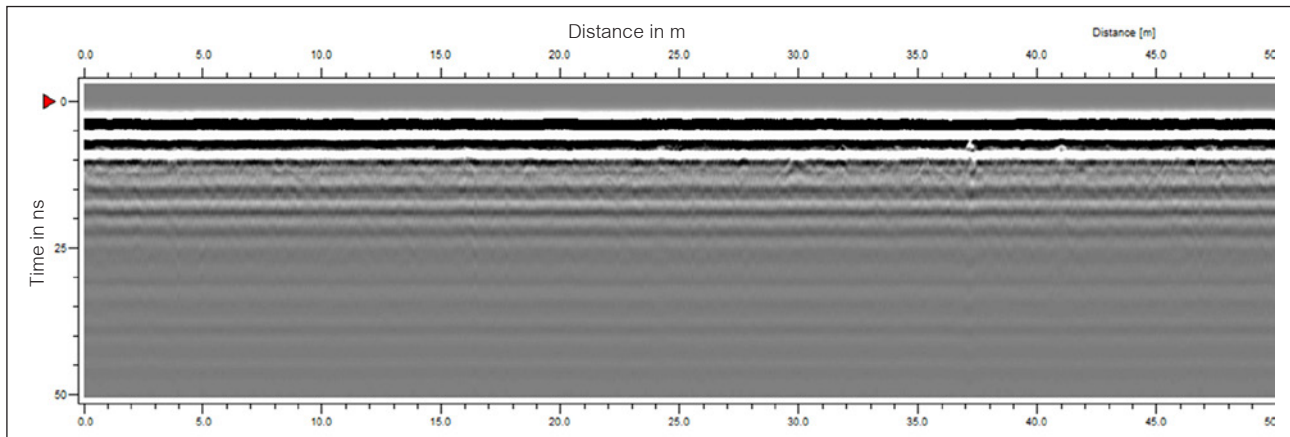
Figure 6 An example of a control scan parallel with the main axis of the garden parterre showing no marks of formal design
Source: author

with the main parterre axis (each 50 m long repeated each 5 m). The research itself was made during the summer months in 2012 as the best scanning results can be reached only in dry and warm conditions.
